**NASA Contractor Report 159261**

VISUALIZATION OF IMPACT DAMAGE OF COMPOSITE  
PLATES BY MEANS OF THE MOIRÉ TECHNIQUE

W. G. Knauss, C. D. Babcock,  
and H. Chai

NASA Grant NSG-1483  
April 1980

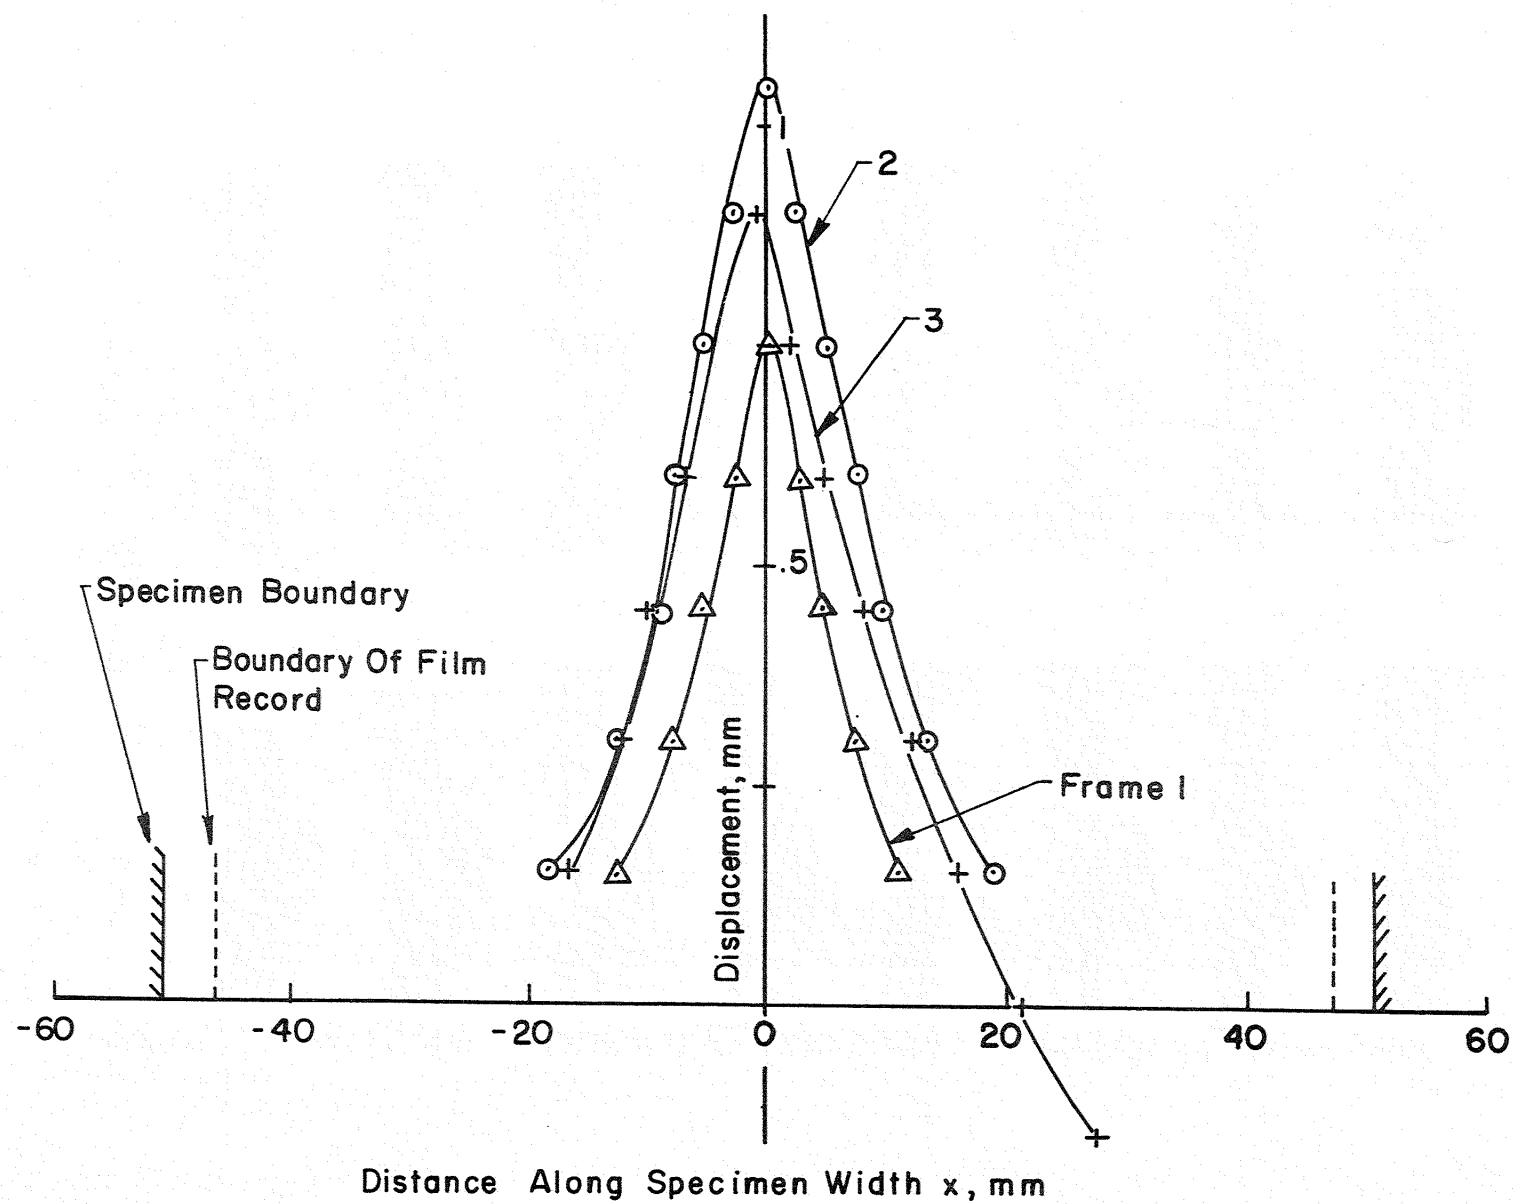
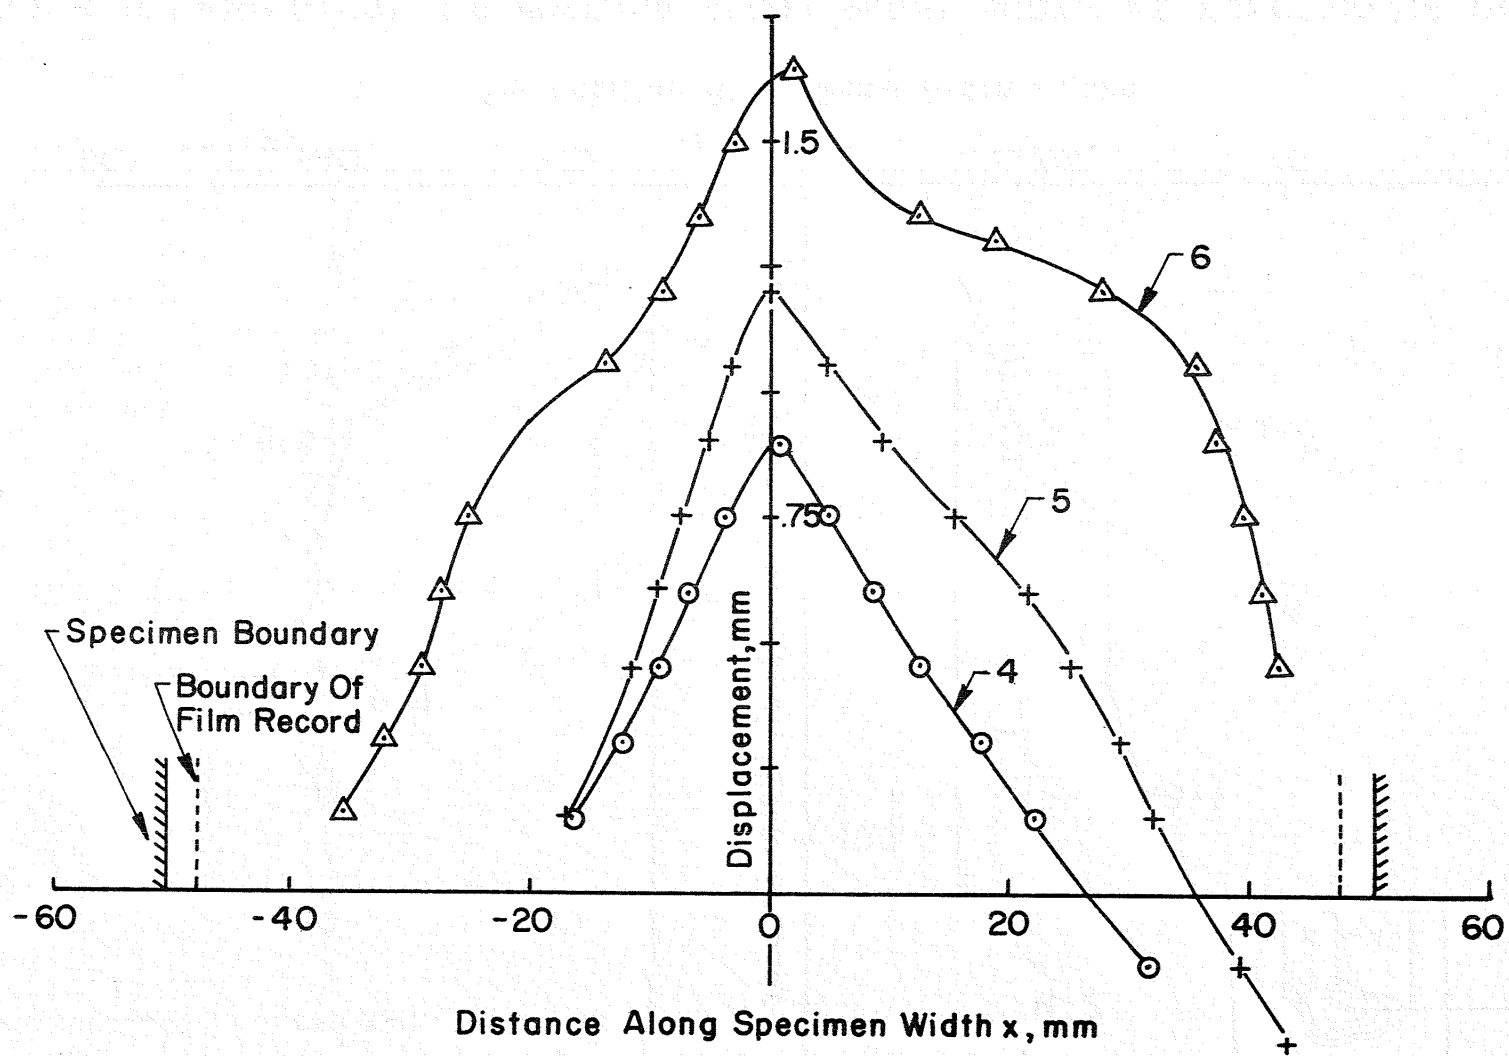
The contours of surface displacements can be converted to displacements and displayed as displacement versus distance plots. This type of result is shown in fig. 17 for test panel B-9. The time between frames is approximately 50  $\mu$ s. The rapid spreading of the damage is evident after frame 4. The velocity of this spreading will be discussed in the next section.

FIG. 17 TEST PANEL B-9 OUT OF PLANE DISPLACEMENT ALONG SPECIMEN WIDTH  
(time interval between frames -  $50.25 \mu\text{s}$ )

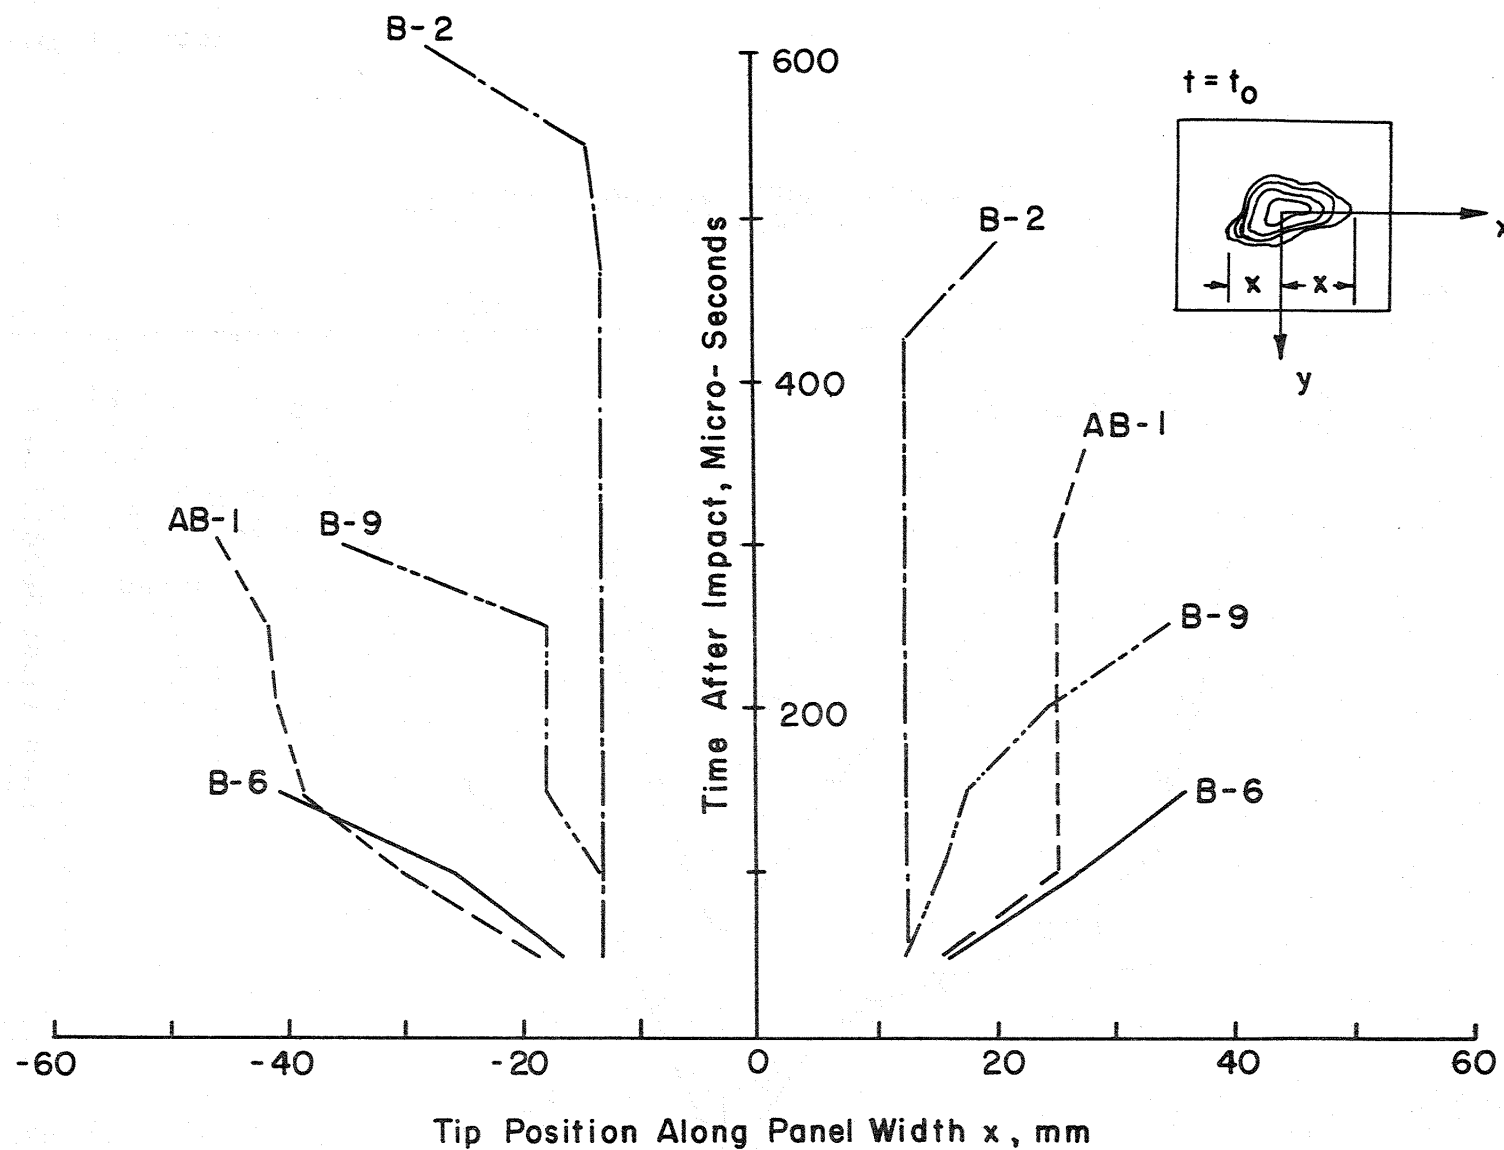
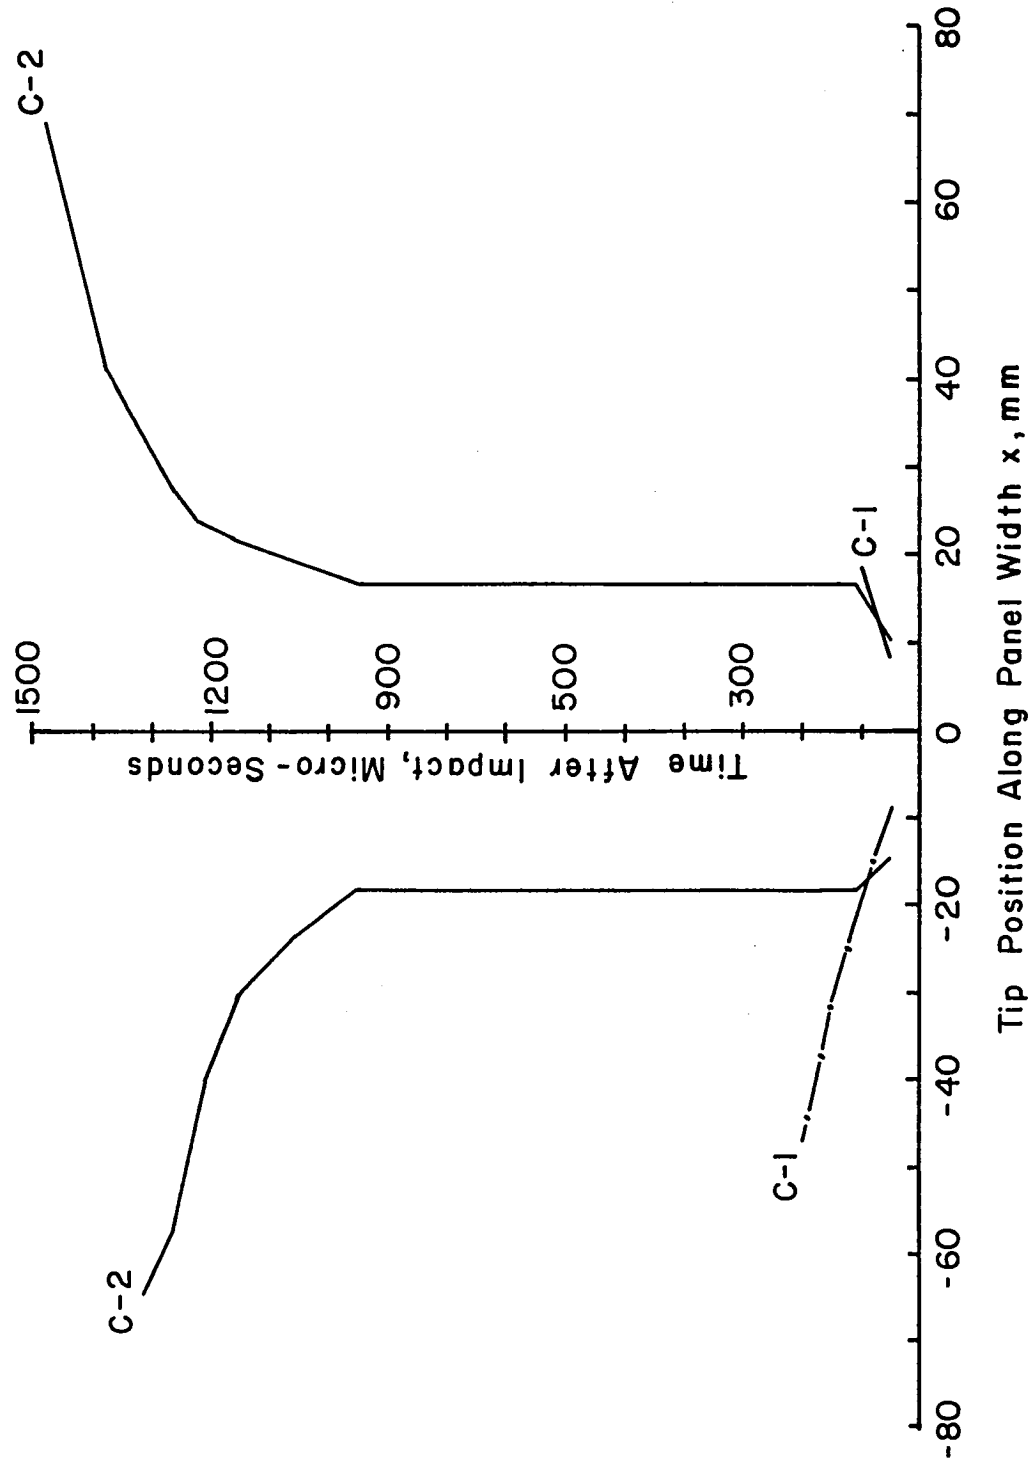
Having commented on the time history of the delamination spreading, it is of interest to indicate an estimate of the rate at which this spreading occurs. This information can be directly found using fig. 18. From this figure it was deduced that the maximum velocity falls in the range of  $1.4 \times 10^3$  m/sec to  $3.3 \times 10^3$  m/sec. The average value of this maximum was  $1.9 \times 10^3$  m/sec (7500 in/sec). While this velocity is substantial it is slow compared to a typical in-plane wave velocity for this material.

FIG.18 DELAMINATION TIP POSITION ALONG PANEL WIDTH AS FUNCTION OF TIME
